# Manhole Inspection Summary

Manhole # S13AA2011MH

Insp Date: **10/12/06 10:42 AM**

**Location** Address: **2300 SOUTH RD**

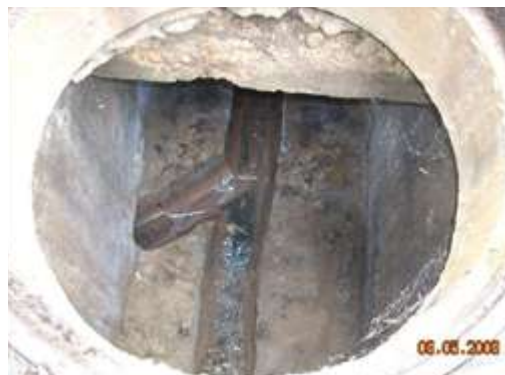
Top View

Bench and Channel debris.

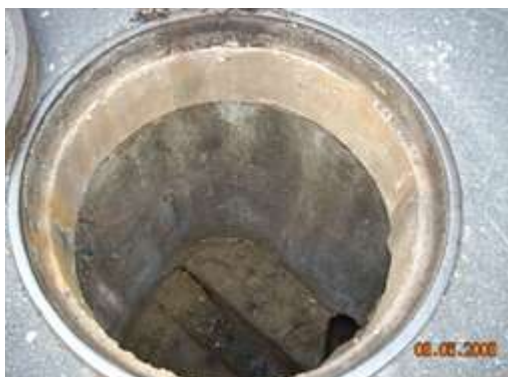
Defect

Frame leaks. Corbel deterioration and infiltration. Barrel infiltration - other side.

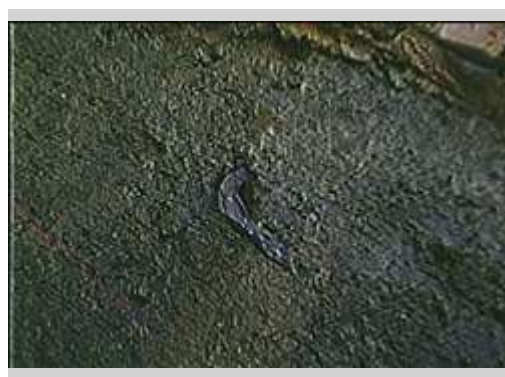
Defect

Corroded and missing steps.

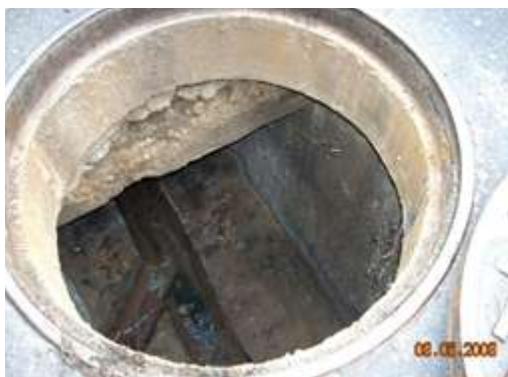
Defect

Frame leaks. Corbel deterioration and infiltration. Barrel infiltration.

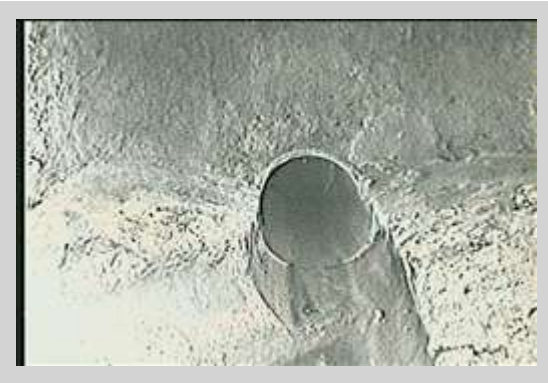
### 8 in. Circular Gravity Sewer Pipe Out @ 12 O'Clock

Barrel deterioration and infiltration..

Infiltration: **Evidence** Pipe Seal Cond: **Unknown**

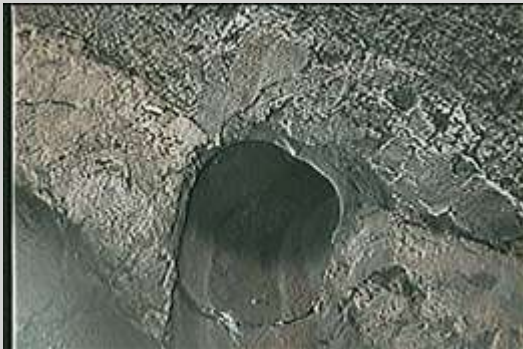
8 in. Circular Gravity Sewer  
Pipe In @ 8 O'Clock

Infiltration: **Evidence** Pipe Seal Cond: **Broken**
